Thermographic Survey of Electrical Systems

May 14, 2019

Electrical Contractor: G Technology, Inc.
Site Thermographer: John Walton, Miguel Guerrero
Date of Survey: May 14, 2019
Time of Survey: 7:00 am
Test Equipment: Flir E75

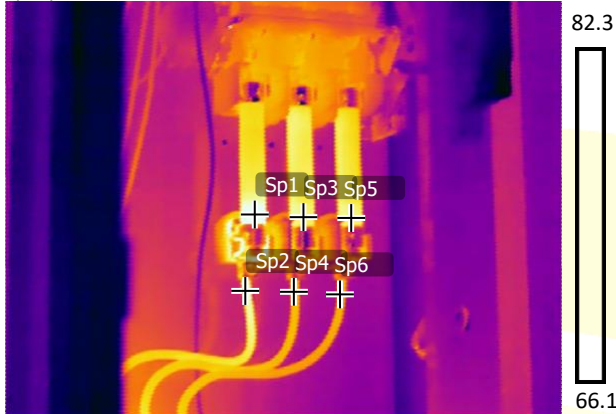
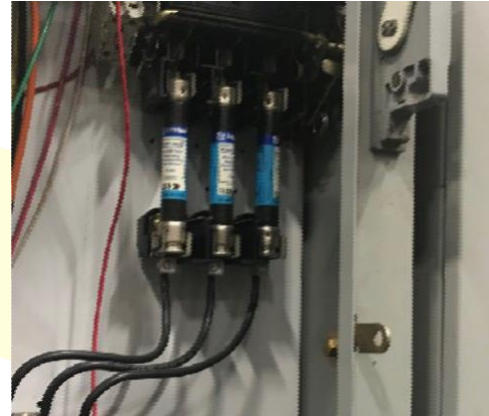
Warehouse Main Floor: Supply Fan 2

Phase A has a loose fuse holder connection.

Rating: Minor

Temperature Difference: 8.4

Replace fuse holder.

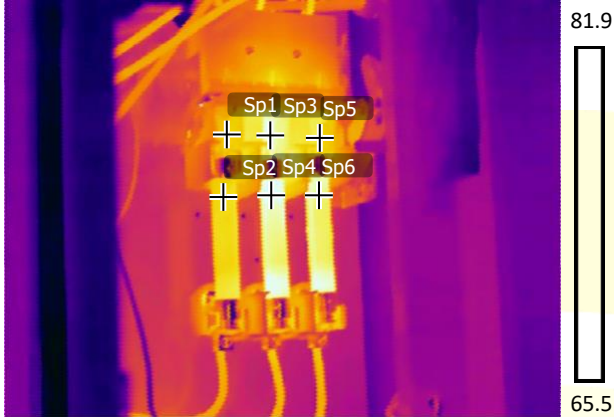
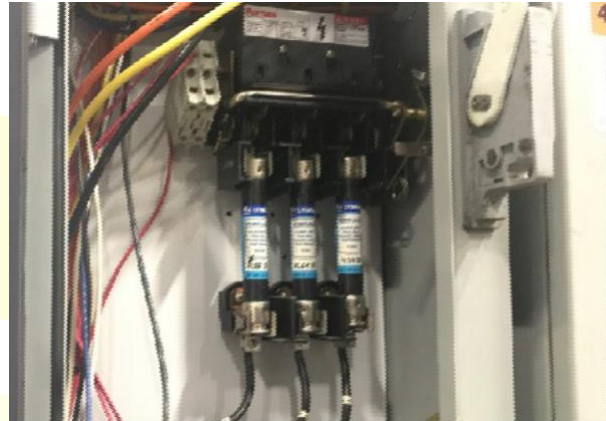
Warehouse Main Floor: Supply Fan 6

Phases B & C have loose fuse holder connections.

Rating: Minor

Temperature Difference: 6.3

Replace fuse holders.

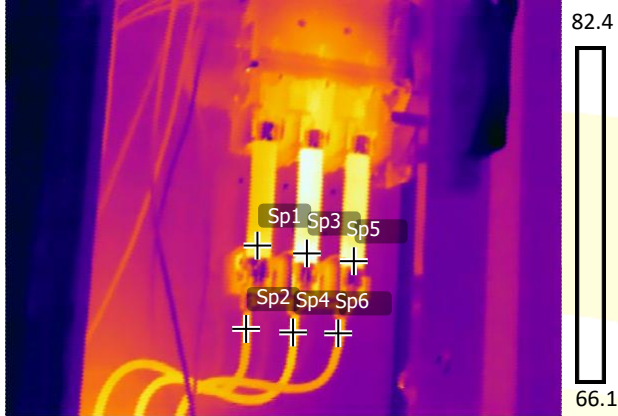
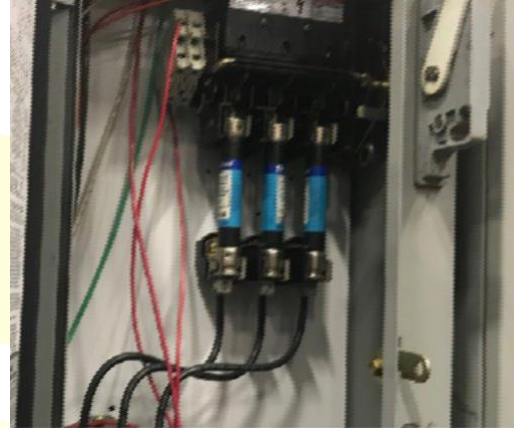
Warehouse Main Floor: Supply Fan 3

Phases B & A have loose fuse holder connections.

Rating: Minor

Temperature Difference: 7.9

Replace Fuse holders.

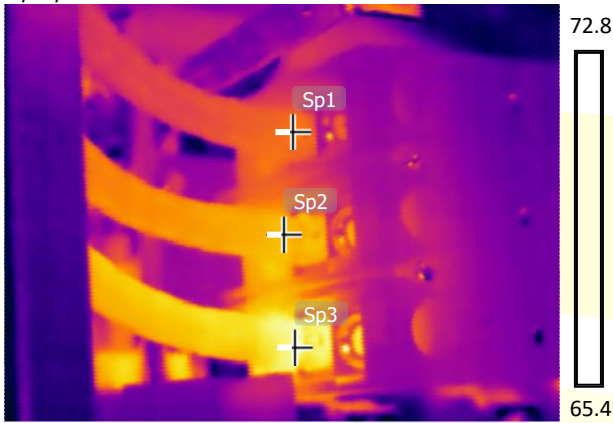
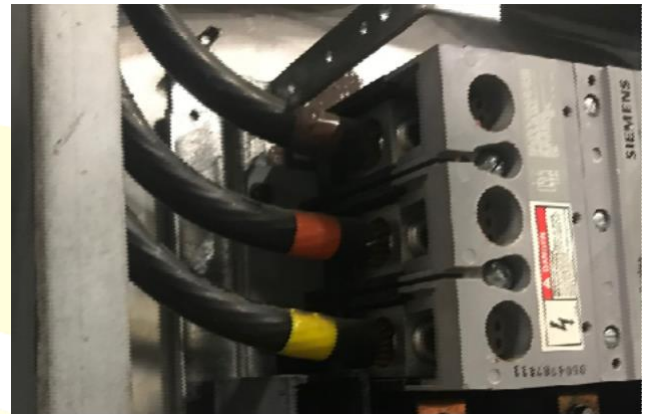
Warehouse Main Floor: Panel BR# 3 (BCP-024)

Main Breaker is internally compromised.

Rating: Minor

Temperature Difference: 2.8

Replace Breaker.

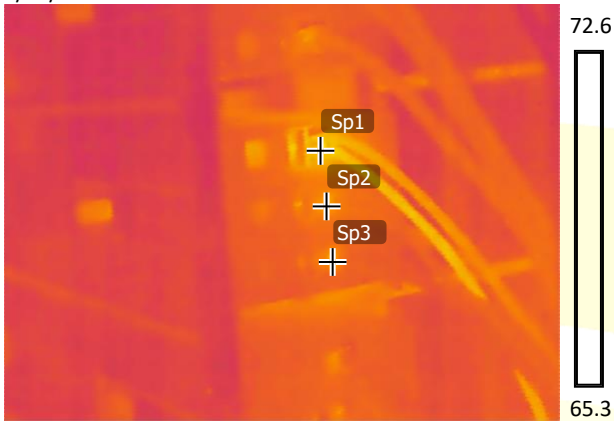
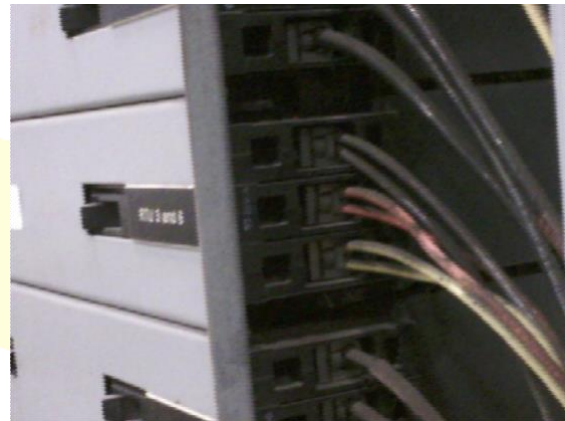
Warehouse Main Floor: Panel LDP (DP-001)

Wire termination was loose inside the breaker. No load at the time of inspection. Couldn't log any measurements.

Rating: Minor

Temperature Difference: 0.9

Push wire in and tightened down lug on breaker.

Repaired on site at time of inspection
By: John Walton, Electrical Technician

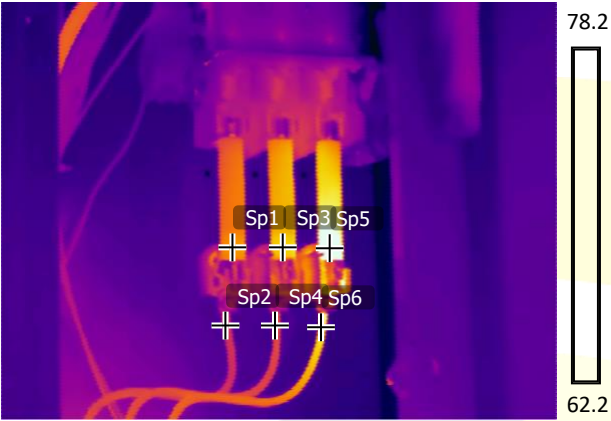
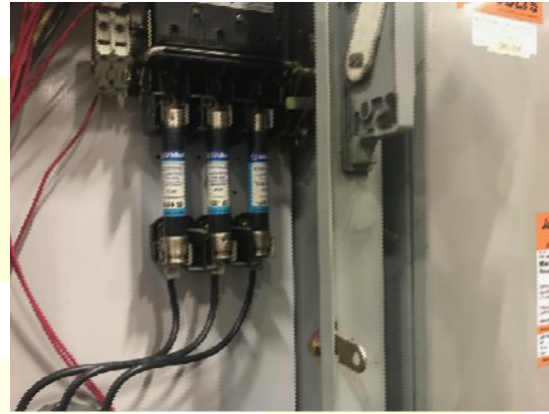
Warehouse Main Floor: Supply Fan 14

Rating: Minor

Temperature Difference: 6.8

Phase C has a loose Fuse Holder connection.

Replace fuse holder.

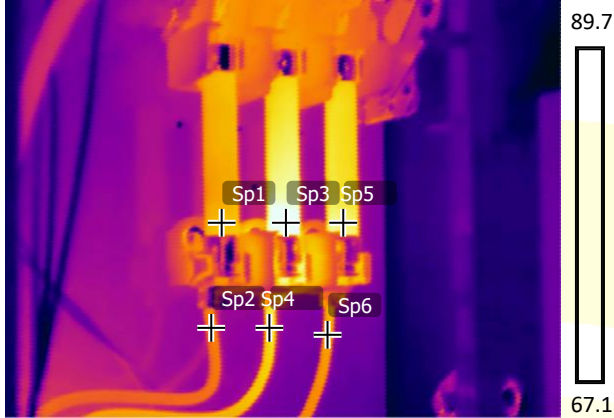
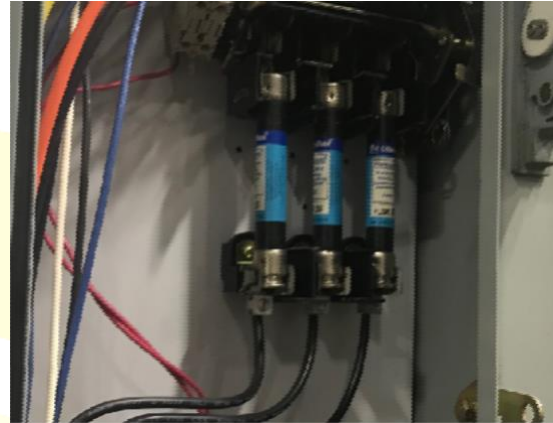
Warehouse Main Floor: Supply Fan 5

Phase B has a loose fuse holder connection.

Rating: Minor

Temperature Difference: 14.1

Replace fuse holder.

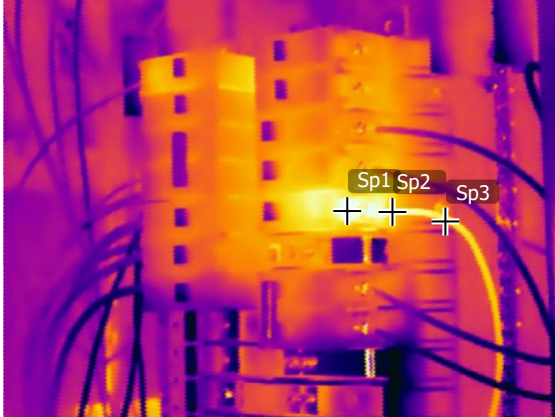
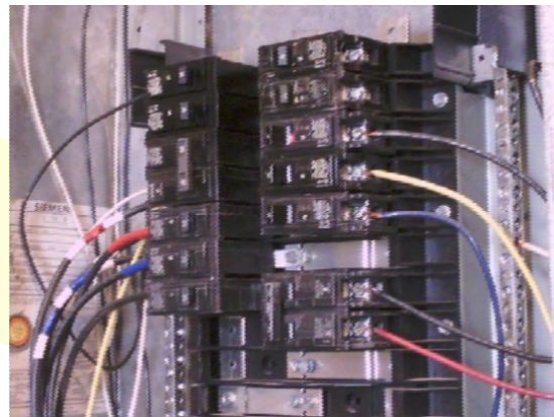
Warehouse Main Floor: Panel B

Found Termination issue with Circuit Breaker #10.

Rating: Minor

Temperature Difference: 3.9

Repair loose connection on site.

Repaired on site at time of inspection

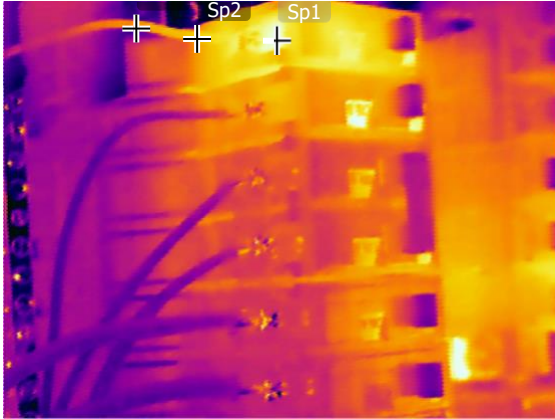
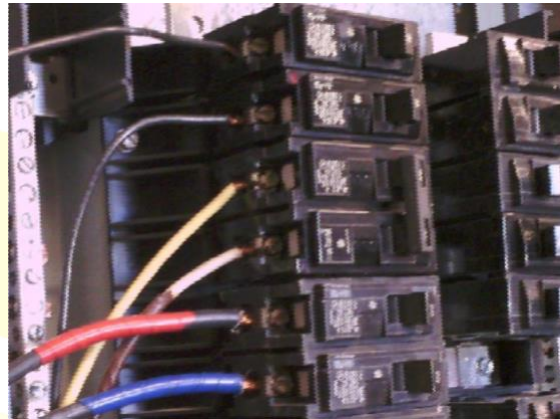
Warehouse Main Floor: Panel B

Found Termination issue with Circuit Breaker #1.

Rating: Minor

Temperature Difference: 3.8

Repair loose connection on site.

Repaired on site at time of inspection
